Manhole Inspection Summary

Manhole # S13UU_005MH

Insp Date: **5/10/07 10:04 AM**

Location Address: **3010 WABASH AVE**

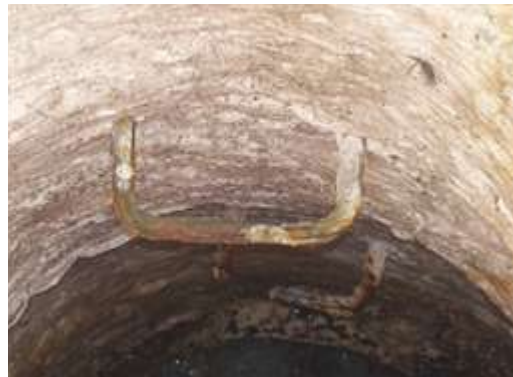
Defect 1

Count: **2** Missing: **0** ☒ **Corroded**

CORRODED RUNG

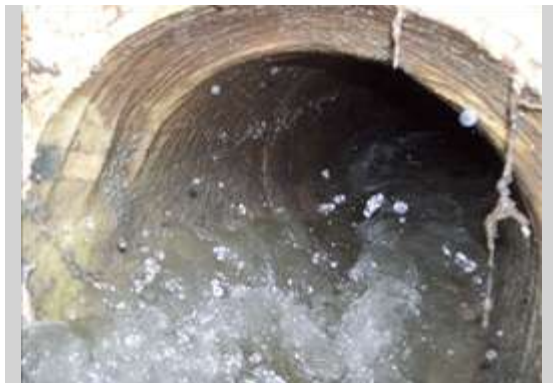
12 O'Clock Outflow

15 in. Circular Gravity Sewer
Pipe Out @ 12 O'Clock

Pipe Material: **PVC** ☐ Pipe Lined

Invert Depth: **10.54** (ft.) Flow Characteristics: **Turbulent**

Infiltration: **None** Pipe Seal Cond: **Sound**

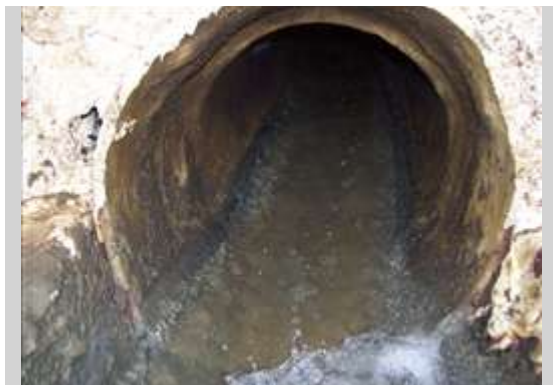
4 O'Clock Inflow

15 in. Circular Gravity Sewer
Pipe In @ 4 O'Clock

Pipe Material: **PVC** ☐ Pipe Lined

Invert Depth: **10.48** (ft.) Flow Characteristics: **Fast**

Infiltration: **None** Pipe Seal Cond: **Sound**

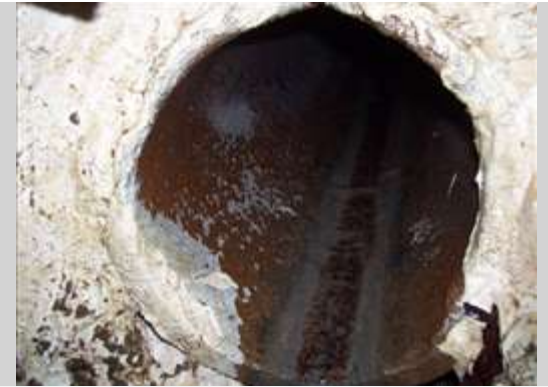
7 O'Clock Inflow

8 in. Circular Gravity Sewer

Pipe In @ 7 O'Clock

Pipe Material: **Clay** ☐ Pipe Lined

Infiltration: **None** Pipe Seal Cond: **Sound**
